# Civic charm: The transformation of Hornsey Town Hall

Regine Kandan  
21 January 2020

## Town Hall: Condition Survey

| Assembly Hall wall lining details | | |

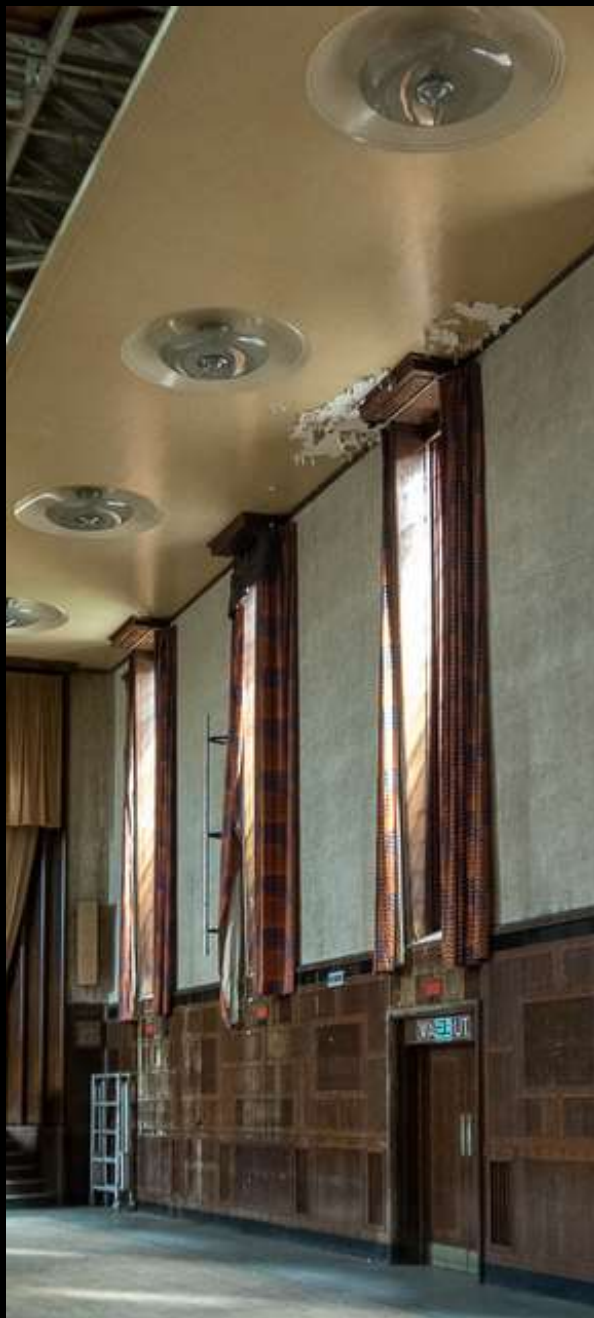
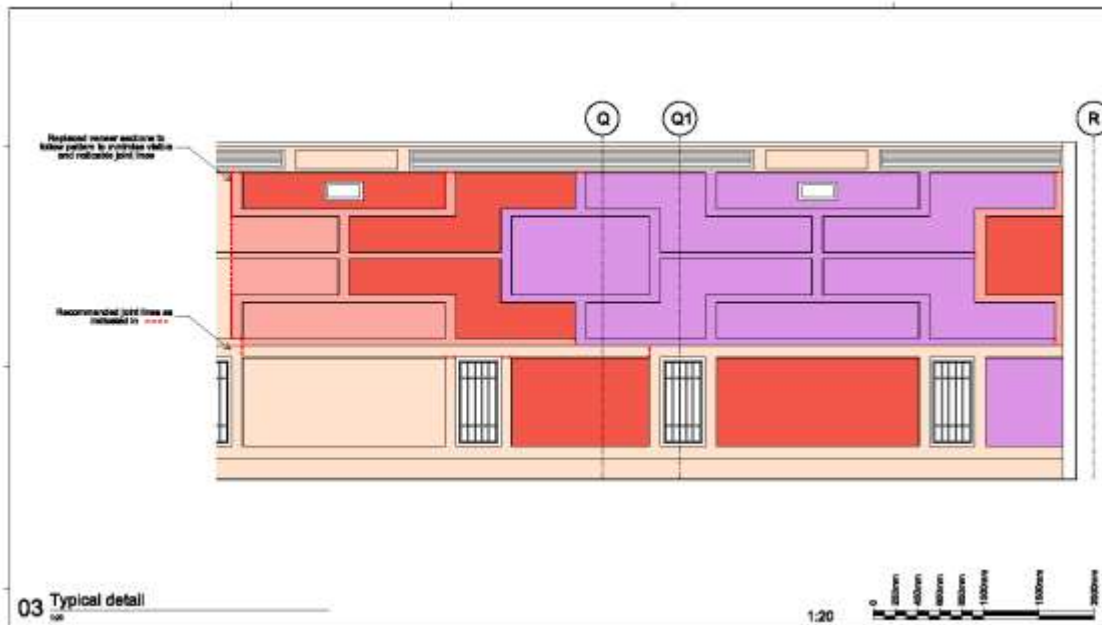
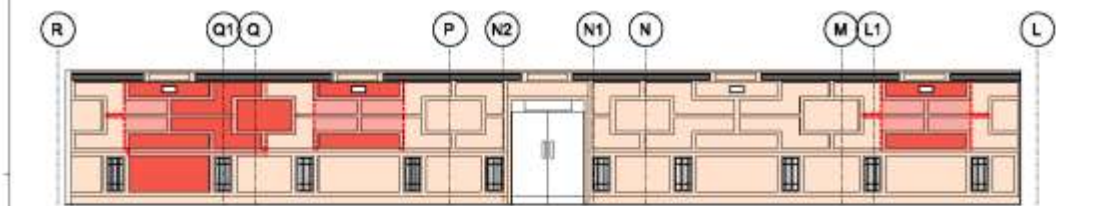
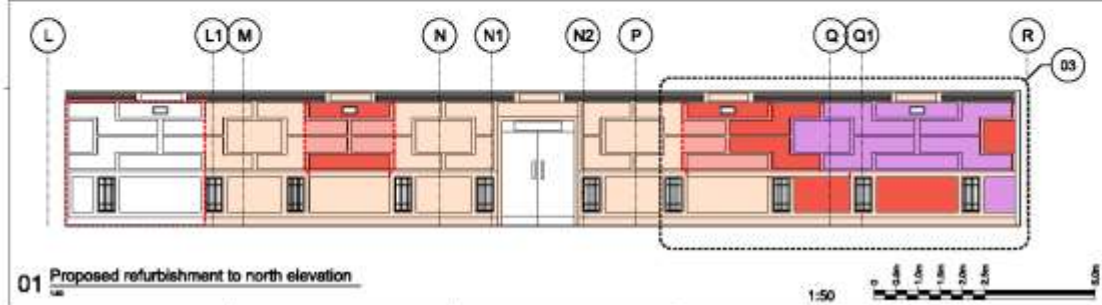
All replacements must be exact replicas of the existing, in grain, finish and beveling

Replacement panels must match direction of grain

| This existing timber linings are to be surveyed and photographed prior to removal. A full condition survey is required in order to confirm the scope of repairs | | |

07 Refurbish existing veneer

06 Locally replace veneers in sections

05 Replace whole veneered pieces

04 Replace full panels

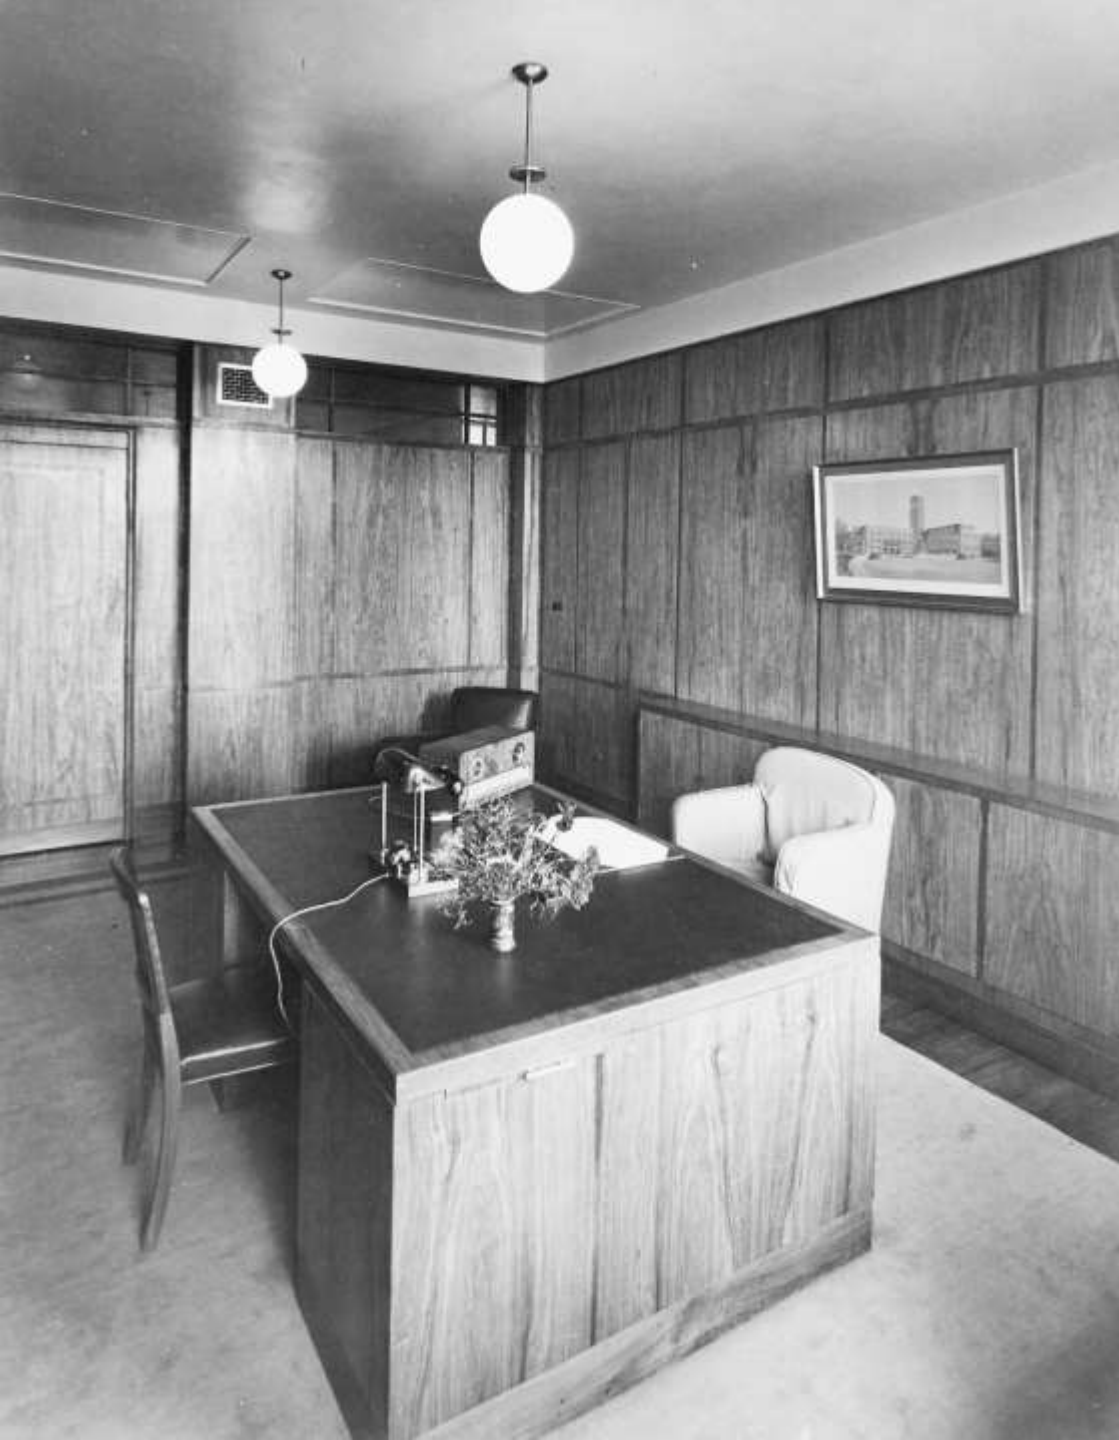
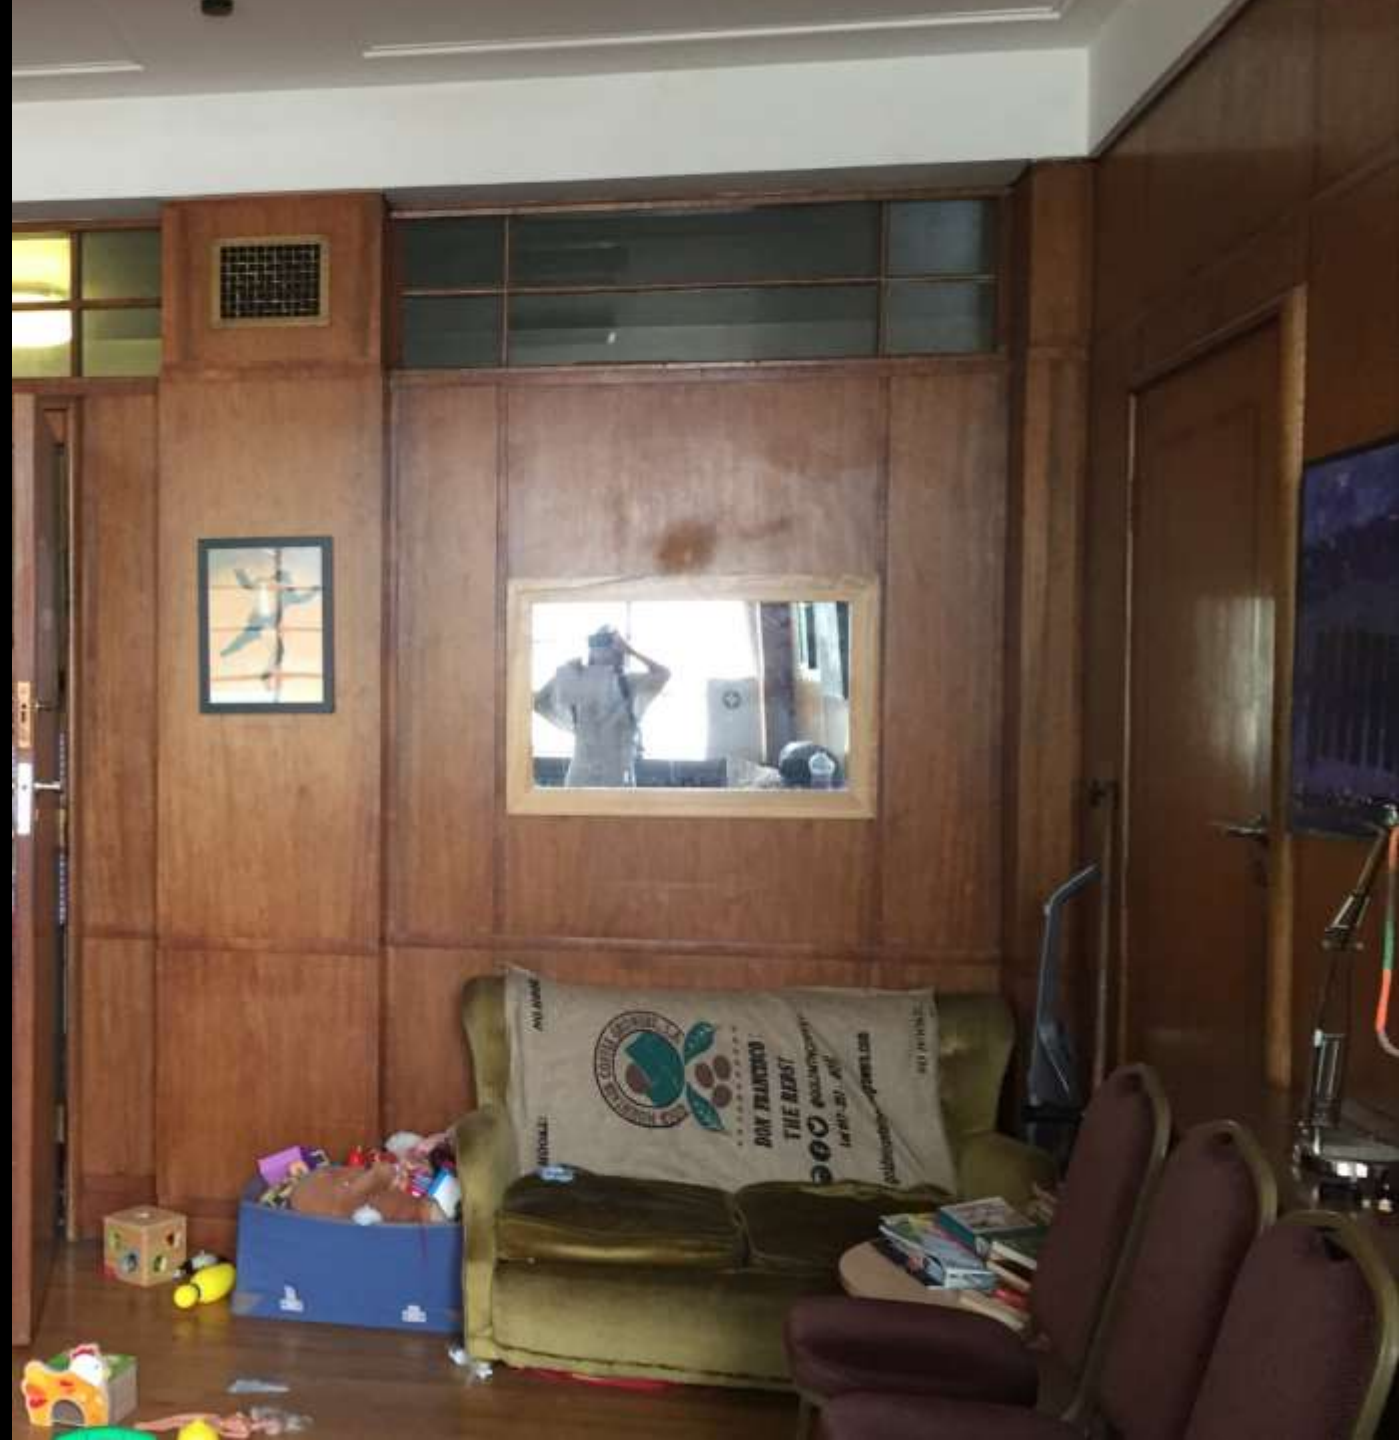
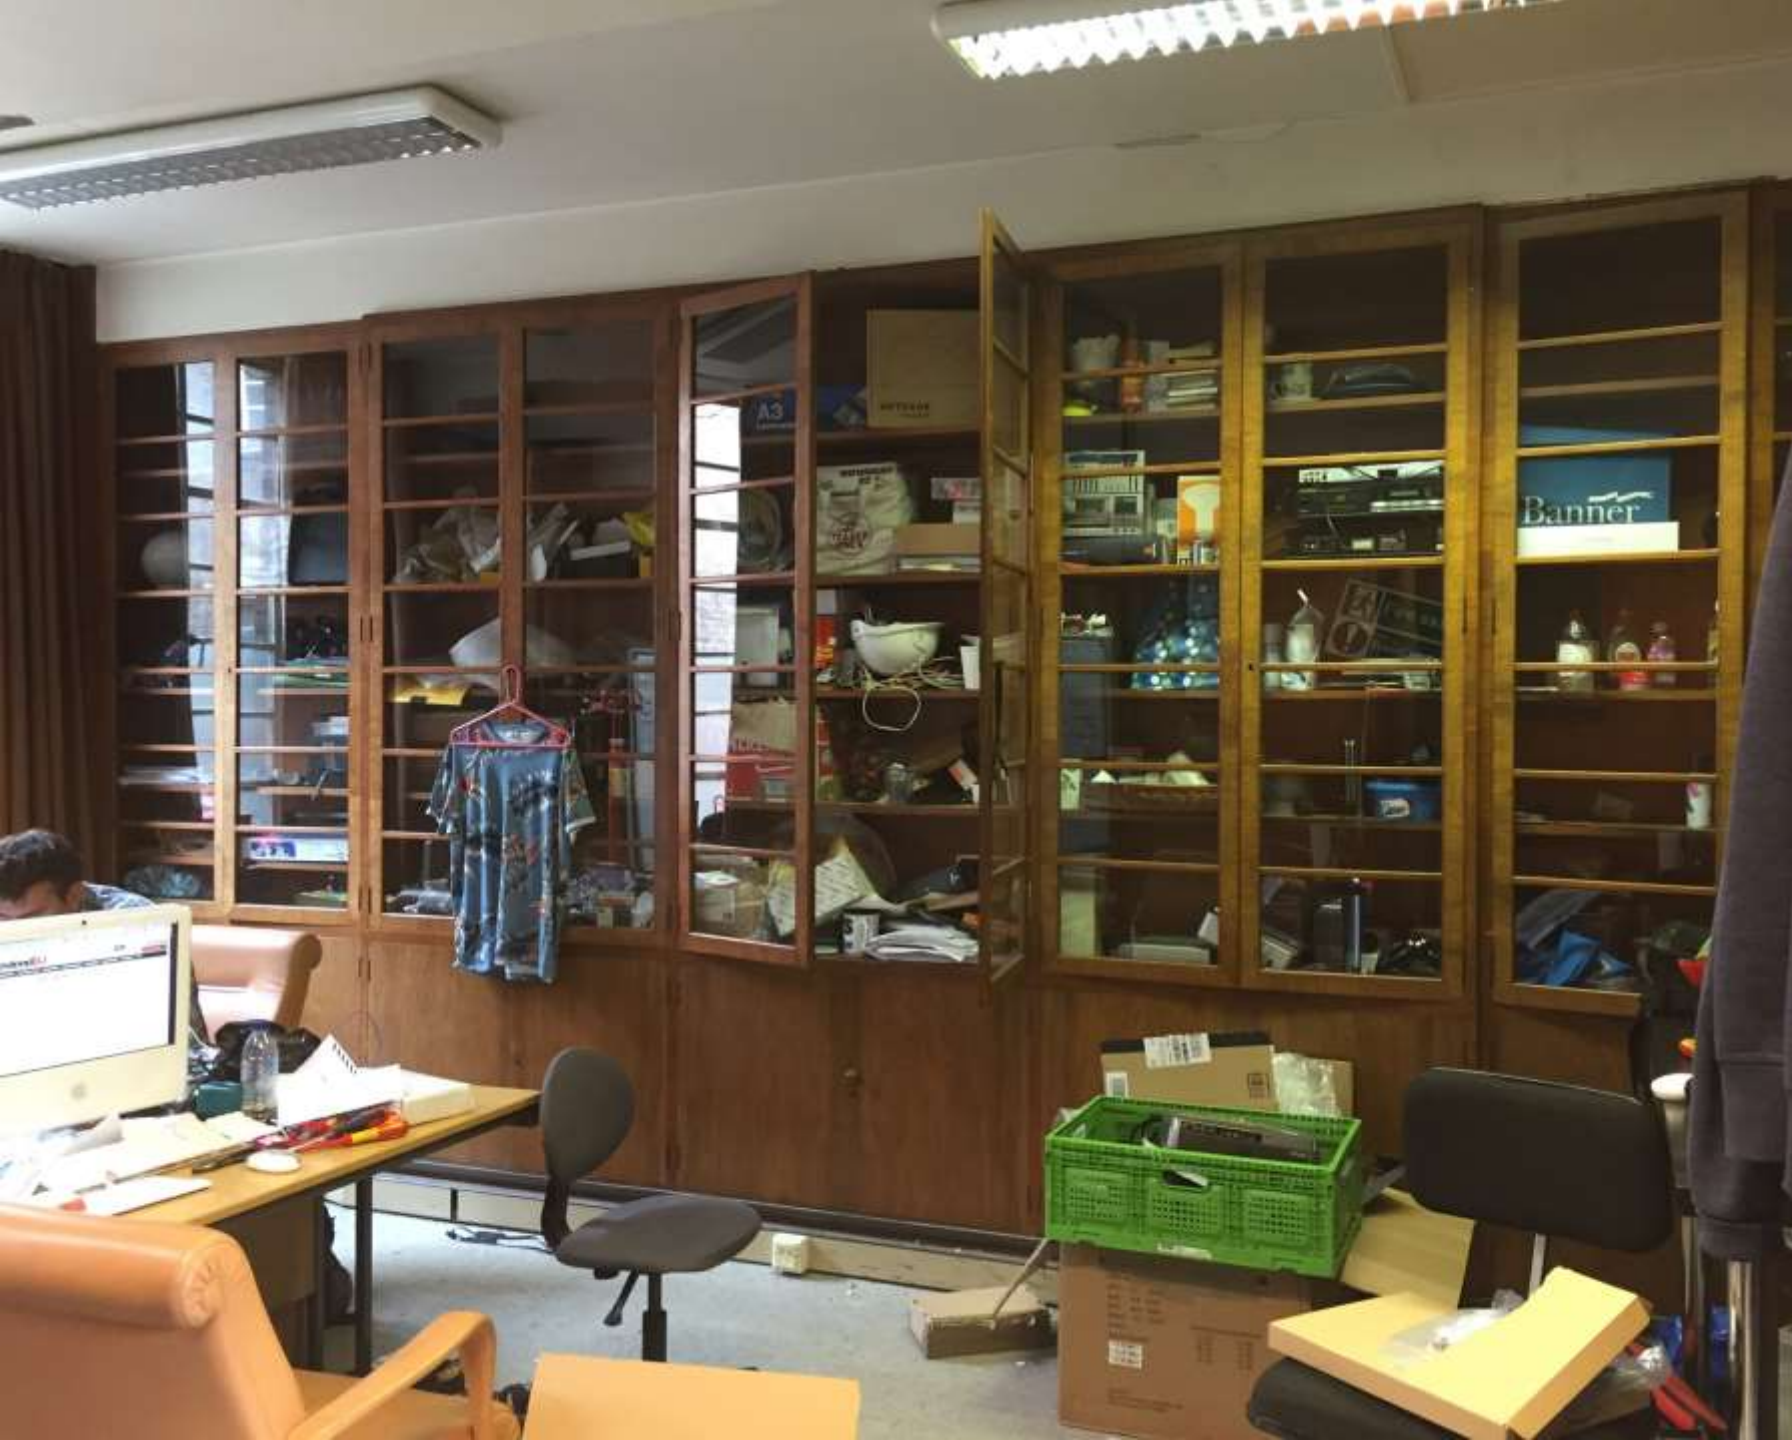
Drawing Title  
Town Hall  
Photographs of existing  
panelled room  
G.8

**01 Existing joinery**  
1:NTS

**02 Existing joinery & timber wall lining**  
1:NTS

**03 Existing timber wall lining**  
1:NTS

**04 Existing timber wall lining**  
1:NTS

**05 Existing timber wall lining**  
1:NTS

**06 Existing timber wall lining**  
1:NTS
