# Hornsey Town Hall Salvage Strategy (ref: HGY/2017/2222)

**Date** July 2019 Stage/Revision Number

The Salvage Strategy sets out a method of removal, storage, reuse and disposal of the historic items defined in the Schedule of Historic Items. This strategy is with reference to the consented proposals detailed in the Listed Building Consent HGY/2017/2222 and LBC variation HGY20190301.

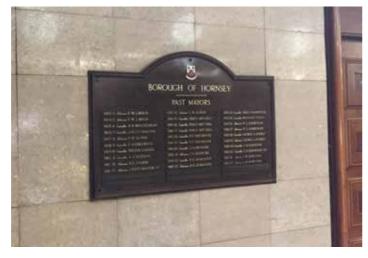
### Item no. 37

2nos original plaques located adjacent to the entrance to the Mayor's Parlour

- Items that are affixed to the building will be carefully removed to protect the elements during the construction works. In some cases such as for the plaques adjacent to the Mayor's Parlour, works are required to carry out repairs to the stone linings. Some panels require re-fixing as they have become dislodged due to failure in the adhesive.
- The items will be carefully dismantled, labelled and packaged. The items will be carefully removed from any primary fabric, minimising damage, and reinstated. Works to make good will be carried out to the existing fabric.
- Elements will be brought to a designated storage facility until required for reinstatement.
- The items will be carefully reinstated on the stone walls, making sure to reuse existing fixing points which have been checked for their integrity and robustness. Care will be taken to not damage the existing fabric.

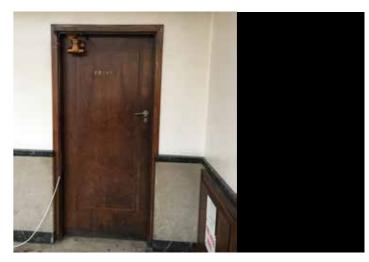
Item no. 62

**Item description:**Retained doors generally

- The items will be carefully dismantled, labelled and packaged. This will include original ironmongery and any original signage.
- The items will be photographed prior to removal and the location of the item will be recorded to guarantee that the reinstatement is like-for-like as the original.
- The items will be carefully removed from any primary fabric, minimising damage, and reinstated. Works to make good will be carried out to the existing fabric.
- Elements will be brought to a designated storage facility for refurbishment, repair and/or upgrade, until required for reinstatement.
- The items will be then carefully reinstated in their original location, making sure to reuse existing fixing points which have been checked for their integrity and robustness. Care will be taken to not damage the surrounding existing fabric.

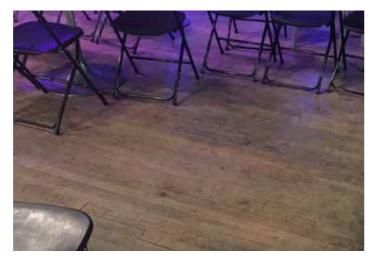
### Item no. 20

Timber flooring in the Supper Room and Assembly Hall stage

- In both situations, the items will be carefully removed from any primary fabric, minimising damage, and reinstated.
   Works to make good will be carried out to the existing fabric.

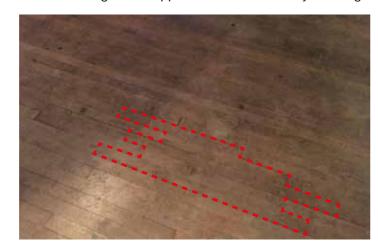
Example of method to remove the individual planks which follows the pattern of the floor. This retains the planks in whole sections so they can be reinstated following the works below.

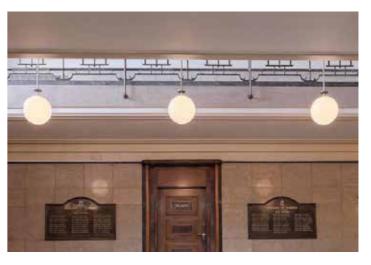
### Item no. 38

Item description:
Original lighting (multiple locations)

- Most of the lights are in their original location and this has been based on archive photographs from the RIBA and Hornsey Historical Society. These lights will be recorded and labelled for reinstatement in the same location. Lights which are found in a different location from where they are known to originate from, or those which are in storage will be labelled based on their new location.

- Following demonstrable disconnection, the items will be carefully removed for repair and/or refurbishment to restore the fittings back to a 'near to new' condition and to meet current building regulations in terms of lux levels and emergency functions.

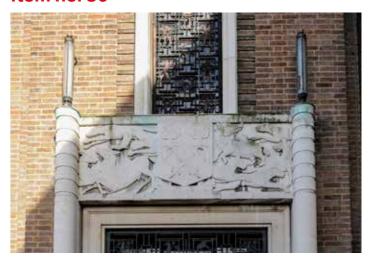
Item description: External lights

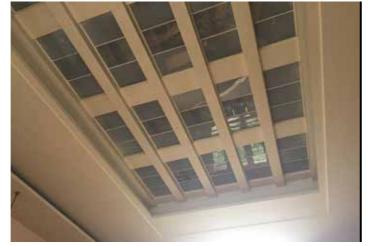
### Item no. 43

Item description:
Laylights in the Council Chamber and Assembly Hall

- The laylights will be cleaned, repaired and adapted by a specialist to serve as LED light panels.
- The items in their current location will be photographed, recorded and labelled. They will then be dismantled carefully from any primary fabric, minimising damage, and reinstated. Works to make good will be carried out to the existing fabric.
- These elements will be refurbished by a specialist off-site in controlled conditions. They will then returned to the building for reinstatement.

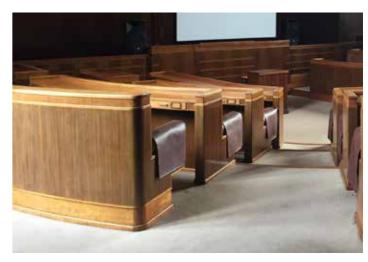
**Item description:**Some fixed seating in the Council Chamber

- In order for the removal of asbestos to take place under controlled conditions, some of the fixed seating adjacent to the wall tapestries will need to be temporarily moved. This is to provide the adequate access for the work.

- The items will be recorded prior to removal. The seats will be carefully removed as components as how they were originally put together.
- The items will be carefully removed from any primary fabric, minimising damage, and reinstated. Works to make good will be carried out to the existing fabric.

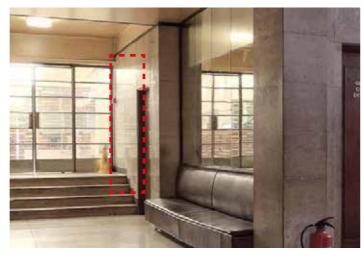
### Item no. 03

**Item description:**Stone wall tiling

- A section of the stone lining will be removed in the ground floor corridor G.46 to make way for a new opening.
- The individual tiles will be carefully taken away by removing the grout and adhesive and slowly lifting the tiles away from the structure.
- The items will be carefully removed from any primary fabric, minimising damage, and reinstated. Works to make good will be carried out to the existing fabric.
- The tiles will be retained as they can be reused to close off the current opening on G.46 and/or repair any damaged stone elsewhere in the building.
- Elements will be brought to a designated storage facility until required for reinstatement.

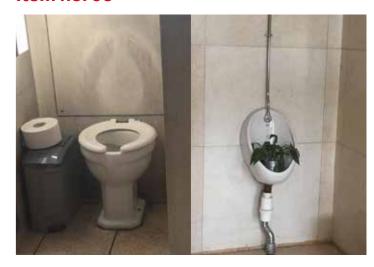
### Item no. 05

Item description:
Original WC pans and urinals

- Original WCs, urinals and basins designated for reuse will be disconnected. Non-original fixtures such as the WC seats and modern taps will be removed permanently.
- These items are to be removed carefully and taken to an off-site facility for cleaning.
- These will be refitted with new seats, new taps to match the original and new pipes so that the element in their entirety will meet building regulations.
- They will be labelled and subsequent to refurbishment, returned to new locations identified in the proposals.

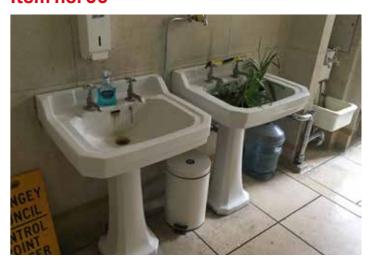
**Item description:**Original basins including cleaners' sinks

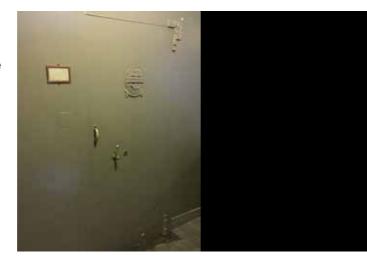
Item no. 18

Item description:
Original John Tann 'Reliance' steel doors (all - 5nos)

- The John Tann 'Reliance' doors will be firstly recorded in its existing, working condition before carefully being dismantled by a specialist. Any components of the door which has to be removed in the process will be labelled and packaged with the same doorset to avoid any loss or damage. The doors will be surveyed and refurbished. New openings will be created in new partitions to reinstate the doors.

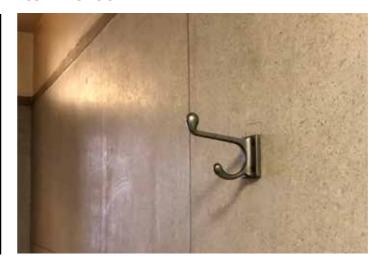
### Item no. 56

Item description:
Original hooks in lavatories

- The original hooks in lavatories will be carefully removed to keep the elements in working condition for later installation. These will be packaged and kept in a storage facility until required on site.

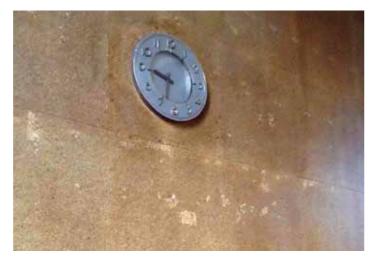
### Item no. 41

Item description:
Original clocks (currently, some are installed in rooms and some are in storage). 73nos assumed but not yet confirmed.

- All the original clocks will be carefully removed from the building. The clocks that are currently installed in their original locations will be recorded and photographed. Clocks which will return to their original locations will be given reference numbers unique to these locations. Clocks that are found in storage will be labelled and given new codes for their new and/or former locations in the building.

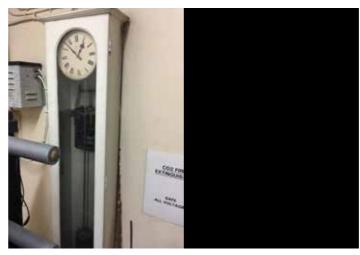
Item description:
Original synchronome clock currently on the Lower Ground Floor.

- The original synchronome clock will also be refurbished.
   This will need to be carefully disconnected from the building and removed in its entirety. It will be repaired and then returned to the building in a new location on the ground floor.

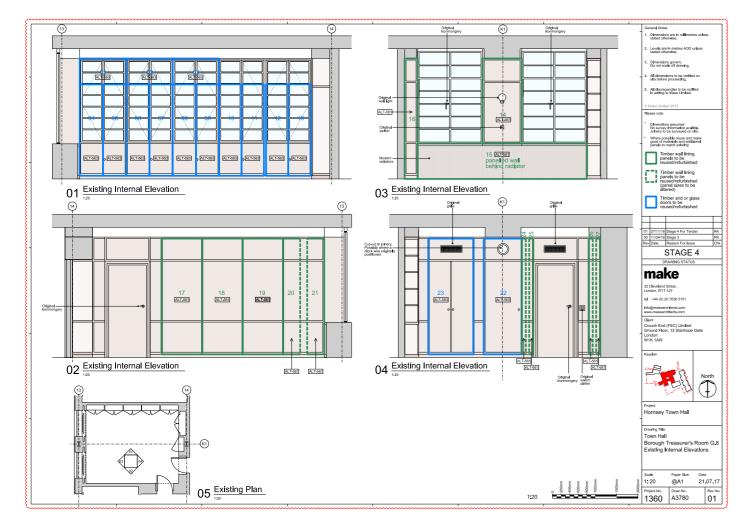
Example drawing recording each joinery element in the existing room configuration

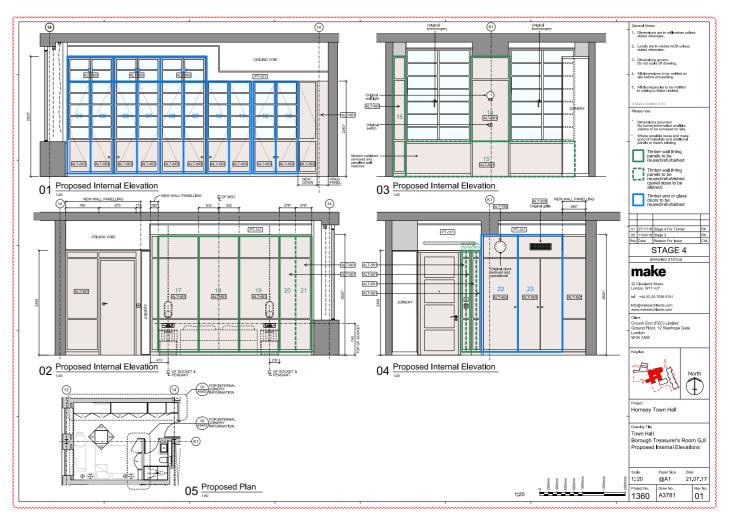
Example drawing recording each joinery element in the new room configuration

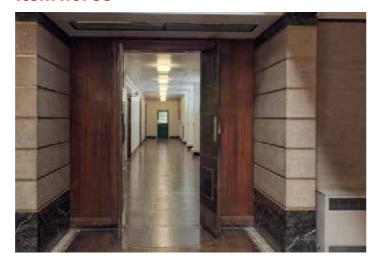
### Item no. 59

**Item description:**Double door to F.49

- Originally, the entrance to the corridor F.49 was open to the foyer. In the later occupation of the Town Hall by Haringey, the entrance door to the Committee Rooms was moved and installed at the corridor, which has resulted in a different door being installed to the Committee Rooms.
- This original door will be carefully dismantled, taking caution not to harm the adjacent timber panelling, although this is also a later addition to the building.

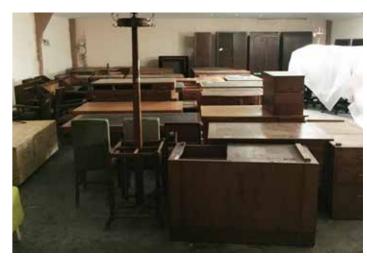
### Item no. 52

Loose furniture formerly used in the Town Hall - desks, tables, chairs, armchairs, sofas, coat stands, cupboards, objects etc. Refer to the Furniture, Fixtures, Fittings and Objects Inventory for full list.

- Each item has already been labelled and listed in an inventory.
- At the designated time in the construction programme, the items will be handed over to a specialist joinery subcontractor who will repolish, reupholster and repair any damaged components of the pieces.

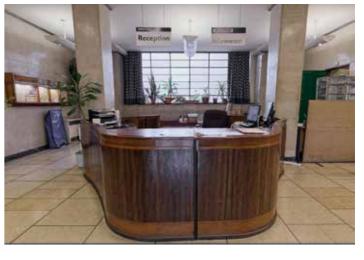
### Item no. 32

Original ballots desk formerly located on the first floor, now on the ground floor.

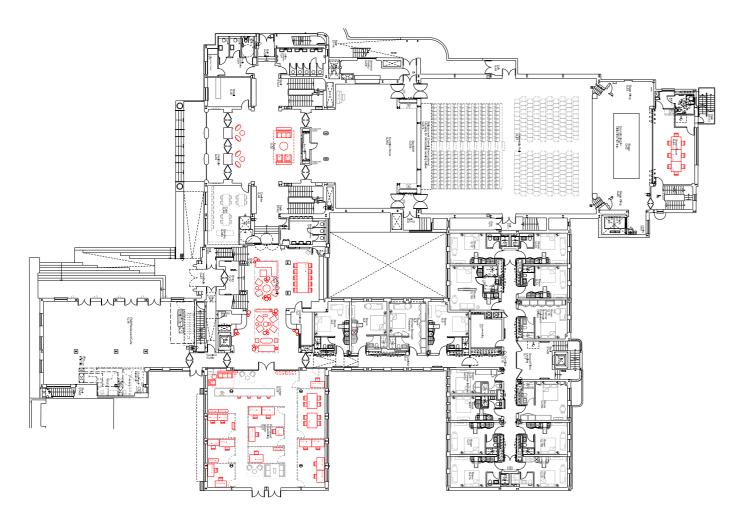
01 Proposed Ground Floor

Example drawing indicating location of the retained furniture on the ground floor

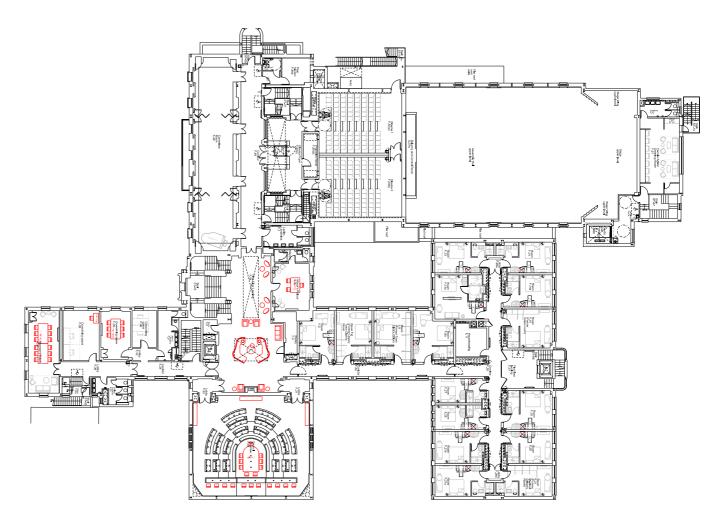
01 Proposed First Floor

Example drawing indicating location of the retained furniture on the first floor

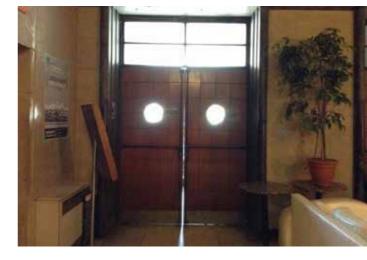
### Item no. 01

Non-original 3nos timber entrance doors (installed post 1935) with circular vision panels on the ground floor facing the Assembly Hall. Upper transoms are retained.

- Original doors will be recorded, dimensionally surveyed and photographed. As replica doors will be fabricated, details and visual characteristics of the doors will be recorded for the reconstruction for example; any beading, sizes of the door and frame profiles, the timber veneer species, colour, direction of grain, type of cut, integrated signage etc.
- Some of the original glazing in the vision panels and portholes have since been replaced with wired glass
- The items will be carefully dismantled and any elements destined to be reused as part of the new works will be removed, labelled and packaged. For example, original lever handles and pull handles will be reused on new doors. Original pot closers which are reusable will be reinstated

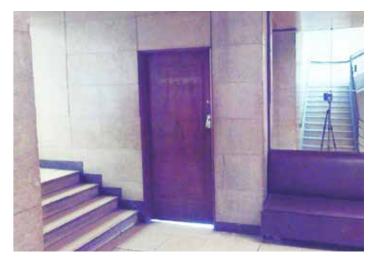
### Item no. 02

Timber door between G.48 (cafe) and G.46 (corridor)

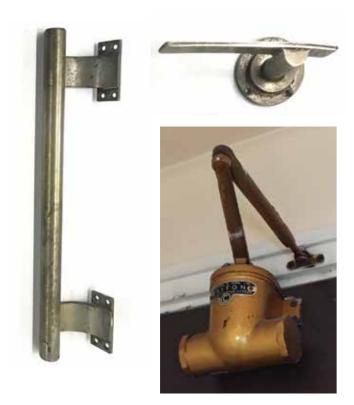
Photographs of original ironmongery to be salvaged and reused

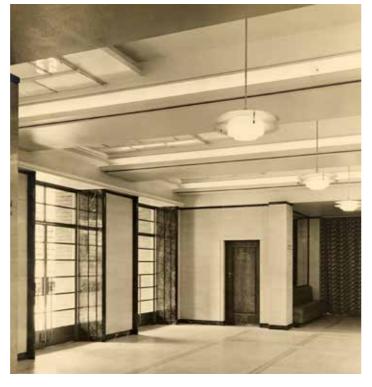
Photographs of original entrance doors from RIBA Archives

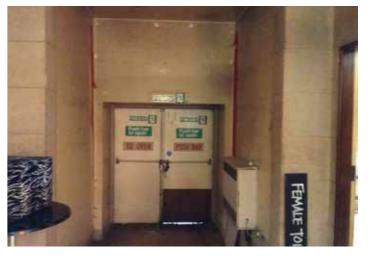
Item description: Fire exit doors (multiple)

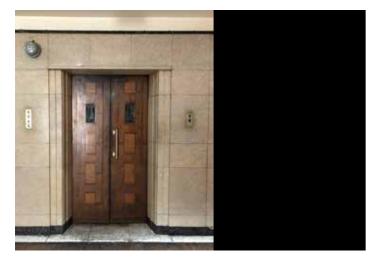
Item no. 30

Item description: Lift doors

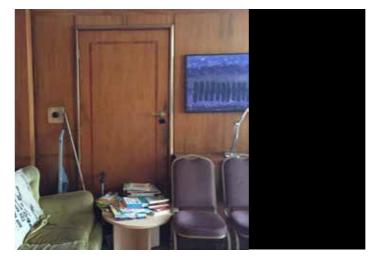
Item no. 58

Item description:
Internal timber veneered doors (multiple locations)

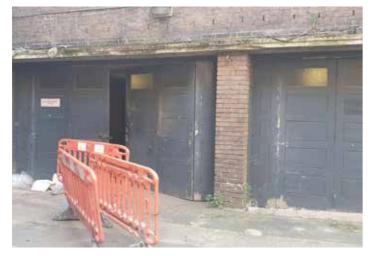
**Item description:** External garage doors (LG.22, LG.22a, LG.22b)

The existing garages will be transformed into hotel guest rooms. Therefore the doors will be replaced with new doors which take the same form as the garage doors i.e. they will be a timber door assembly which replicates the same pattern but with glass inlays.

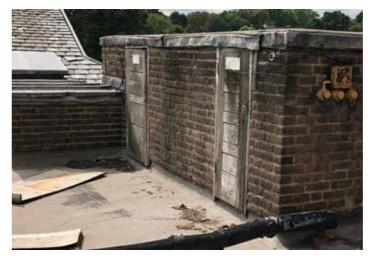
Item no. 71

Item description:
External timber doors (multiple locations)

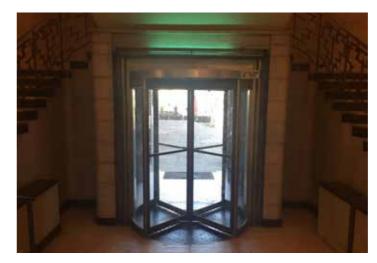
### Item no. 08

**Item description:**Non-original revolving door at the administrative entrance

- Original doors will be recorded, dimensionally surveyed and photographed. As replica doors will be fabricated, details and visual characteristics of the doors will be recorded for the reconstruction for example; sizes and details of framing elements including profiles. The items will be carefully dismantled and any elements destined to be reused as part of the new works will be removed, labelled and packaged. For example, original pull handles will be reused on new doors.
- Some of the glass has since been replaced with wired glass
- The items will be carefully removed from any primary fabric, minimising damage, and reinstated. Works to make good will be carried out to the existing fabric.

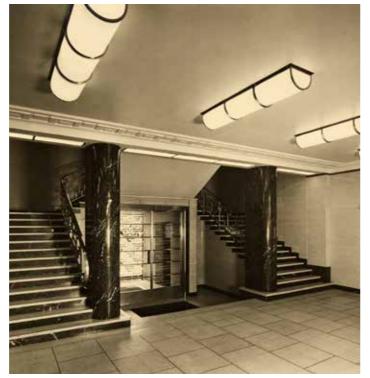
Photographs of original entrance doors from RIBA Archives

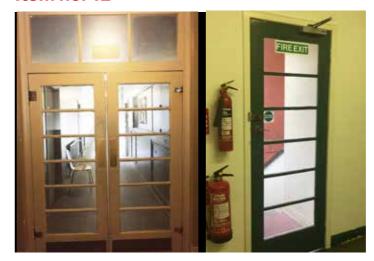
### Item no. 12

A mix of original and non-original doors. Doors located in corridors were installed after 1935, most likely in response to changes in fire regulations. Doors located in stair wells appear to be original or with original ironmongery.

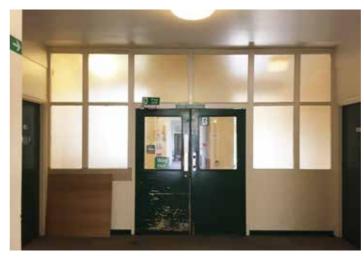
### Item no. 13

Non-original East Wing stair lobby partition and doors which are later additions to the original 1935 design,

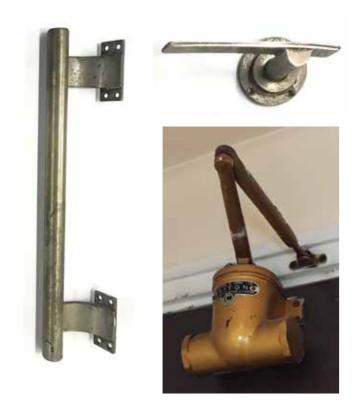
Photographs of original ironmongery to be salvaged and reused

- Original pot closers which are reusable will be reinstated on retained doors where these closers are damaged or absent.
- The items will be carefully dismantled and any elements destined to be reused as part of the new works will be removed, labelled and packaged. For example, original pull handles will be reused on new doors.

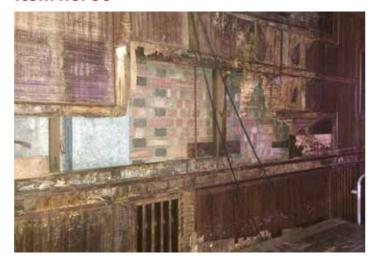
### Item no. 50

# Item description: Timber panelling in the Assembly Hall (Example of panelling beyond repair)

- There will be some elements (panelling and support structure) that will be beyond repair due to high levels of rot as a cause of water ingress. These will be carefully removed and differentiated from the surrounding repairable and reusable panelling, including any primary fabric, minimising damage, and reinstate/ make good to the existing fabric.

- The elements that cannot be repaired will be disposed of.
- Panelling that can be repaired will be carefully removed subsequent to being recorded. The panels will be repaired and refurbished off-site to ensure that the works are carried out under controlled conditions.

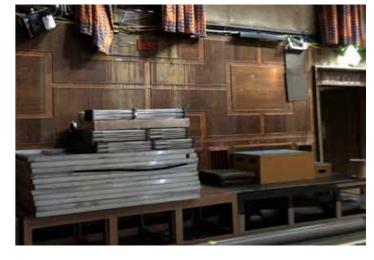
Item description:
Timber panelling in the Assembly Hall
(example of panelling that can be rejuvenated and reused in its totality)

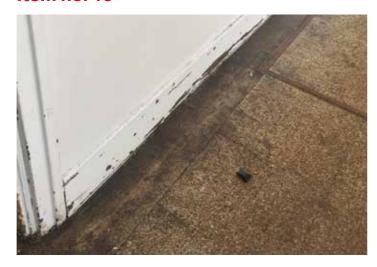
### Item no. 16

**Item description:**Cork floor tiles which interface with partitions being removed.

- Where alterations to the planform take place, floor finishes will have to be altered to suit the new room configurations.
- This applies to the cork floor in the hotel corridors, the timber floor in the cloakrooms G.48 and G.50, and the tiled floor in the kitchen LG.41.
- The finishes will be carefully removed from any primary fabric and from the adjacent existing finish which needs to be retained, minimising damage, and reinstated. Works to make good will be carried out to the existing fabric.
- The removed finishes will be reused for localise repair onsite where required. Any remaining finish will be disposed of.

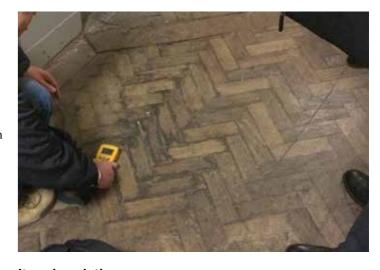
Item no. 27

**Item description:**Localised removal of timber flooring in Lower Ground Floor corridors LG.13. LG.20.

- Specialist initial examination reported the existing floor to be in a generally 'poor' state of repair at times with a WMC of 20% or greater timber begins to rot at 20%. There appears to be no damp proof membrane, however, laid with dipping grade bitumen which in itself would have initially acted as a DPM, the bitumen adhesive has subsequently become brittle and there are significant areas of loose blocks and moisture damaged blocks

- The reusable blocks will be packaged and brought to an
  off-site facility for refurbishment whilst the corridor works
  take place and the DPM is applied on site. New timber will
  be required as not all the flooring can be salvaged. The
  flooring is likely to be laid off-site in its herringbone pattern
  and brought as a pre-cast unit to be installed on site.

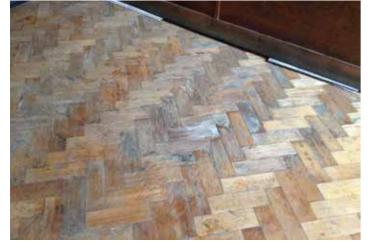
**Item description:**Localised removal of timber flooring in G.50 (former ladies cloak room)

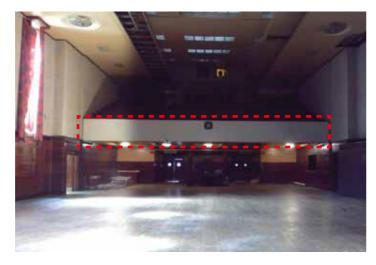
### Item no. 34

**Item description:**Balcony edge which has been clad in acoustic tiles in the 1960s

- The non-original acoustic tile will be removed and disposed of. The balcony structure will be retained insitu.
   It is likely that new structural elements will be fabricated to connect to this main structure.
- The original clock will be retained, packaged and labelled along with the remaining clocks. This clock will be reinstated on the new separation wall in the Assembly Hall.

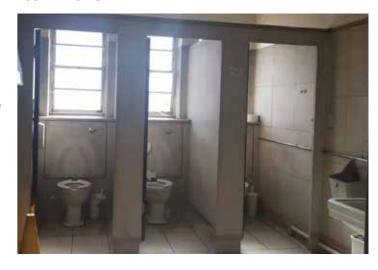
### Item no. 54

Item description:
Terrazzo wall finishes and cubicle dividers

- The existing lavatories will be photograph and recorded prior to the removal for change of use.
- The cubicle dividers are of an insitu terrazzo construction which makes the dividers difficult to reuse.
- However terrazzo tiles are utilised on the floors and walls.
   As these are panelised and modular, the removal and reuse would be more feasible.
- The tiles will be cut-out following the grout lines. These
  may be able to be salvaged and reused for patch repairs to
  existing retained lavatories.

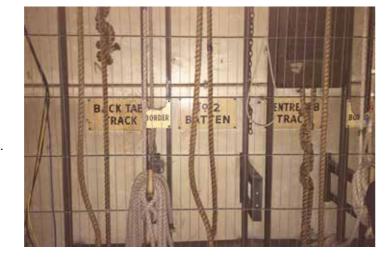
### Item no. 21

**Item description:**Stage scenery lift equipment and system (southern elevation)

- The stage scenery equipment is not proposed to be reused with the theatre, but elements of it will be retained as evidence of the former use of the Assembly Hall.
- The equipment consists of signage, ropes, weights and tracks.
- The connecting counter-balance weight system will be partially disconnected as the southern elevation will be reduced in order to accommodate a new goods and disabled lift. The northern elevation will largely stay intact.
- Further details will need to be developed with the theatre specialist.

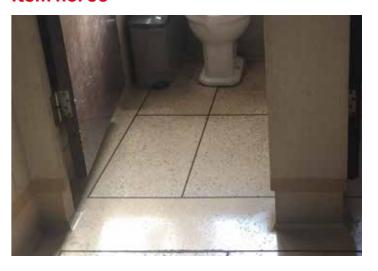
Item description:
Terrazzo floor finishes in the lavatories

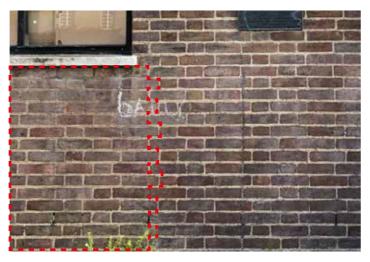
### Item no. 65

Original bricks - handmade of multiple tones of pink, orange, purple and brown

- Where extensions are formed, openings are being made in the existing masonry wall or where existing openings are being enlarged, the brickwork is to be removed individually to retain as much of the brick's integrity and to avoid any harm to the adjacent retained wall.
- These bricks will be reused either in the new East Wing extension, Lower Ground Floor extension, new external enclosures to the goods lift and dumbwaiter or to replace any irreparable defaced or debonded brickwork on the facade.

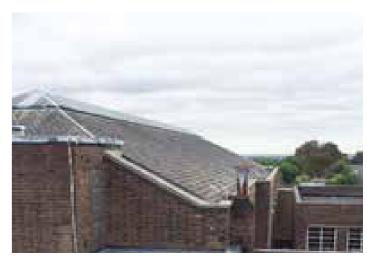
### Item no. 75

Item description:
Roof slates on the roof of the Assembly Hall

- As part of the major repair works to the Assembly Hall roof, the existing slate will be removed and any reusable slate will be retained and reused in the new covering.
- The retained slate will also be used as examples for new matching slate.
- The tiles will be carefully removed from the roof, packaged and brought to an off-site facility to avoid any damage to the components during the construction period.
- Once the roof has been repaired, the tiles will be returned to site and reinstated on the roof along with new matching slates.

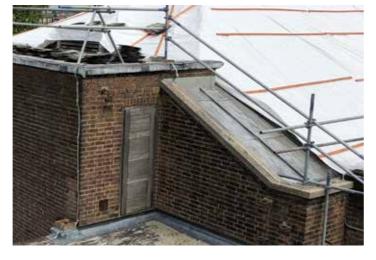
### Item no. 72

Roof coping stones (multiple locations where alterations to the roof occurs)

- Where roof alterations take place for example, on the western section of the Assembly Hall, existing concrete coping stones are to be removed, with care given to avoid harming any retained brickwork or roof finishes.
- Where possible, these coping stones will be reused in the altered roof profile. Where loose, damaged or irreparable coping stones require replacement, the removed elements will be used.
- · Any additional material will be disposed of.

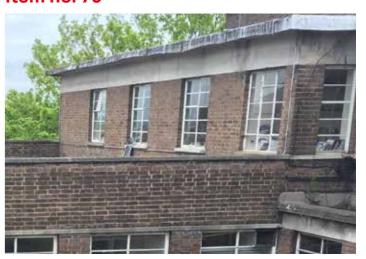
**Item description:**Stone fascia and lintels

- As part of the works to extend the second floor of the East Wing to expand the number of rooms, the northwest and southwest East Wing facades will be stripped-out carefully
- The stone elements will be cut-out individually.
- Where the elements are in good condition and able to be adapted to the new extension, these will be reused. They will also be used to replaced any damaged stone elements on the rest of the facade.
- They will also be used as example to source and match new materials.
- Any additional material will be disposed.

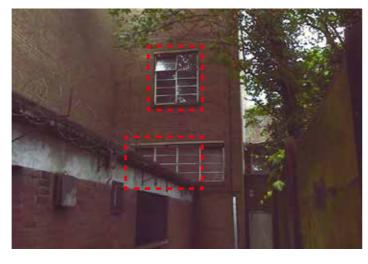
### Item no. 66

Item description:
Steel casement windows (full / part removed)

- The windows will carefully removed by hand-held tools to avoid any impact to the surrounding brickwork. It may be likely that individual components are be removed in piecemeal to minimise damage.
- The work will involve the removal of internal window boards and reveal linings, minimising damage to the fabric, and reinstating breakaway from deeply embedded cramps.
- Existing original ironmongery will be retained and reused in new windows; or in windows where the ironmongery is absent or damaged.
- The removed windows will be used as examples to cast profiles for new windows which will match the existing likefor-like.
- Where windows are partially removed, the window in its entirety will be removed in order to adapt the altered casement to its new size.
- The unused elements will be disposed of.

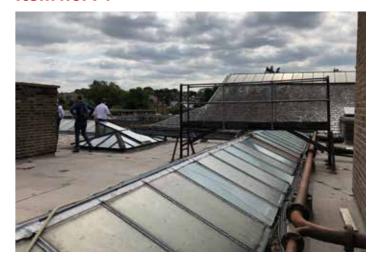
### Item no. 74

**Item description:**2no glazing panels in retained rooflight

- In order to upgrade the building to meet current fire regulations, the fire strategy requires automated opening vents to be installed in the central stair foyer.
- The rooflight will be recorded prior to the alteration.
- Two of the existing panels will be carefully removed, taking precaution not to compromise the system in its entirety.
- The panels and rooflight will be measured and surveyed to fabricate the new vents.
- The panels that will be replaced, will be disposed of.

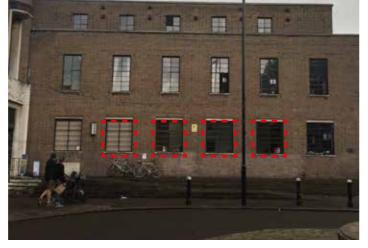
### Item no. 67

Item description:
Bronze casement windows (4nos)

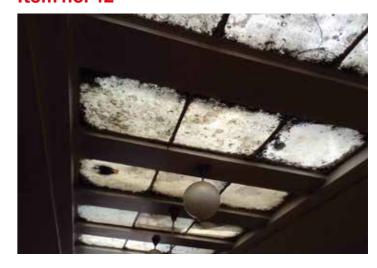
**Item description:**2no laylight glazing panels above second floor landing S.33

- In order to upgrade the building to meet current fire regulations, the fire strategy requires automated opening vents to be installed in the central stair foyer.
- The laylight will be recorded prior to the alteration.
- Two of the existing panels will be carefully removed, taking precaution not to compromise the system in its entirety.
- The panels and laylight will be measured and surveyed to fabricate the new vents.
- The panels that will be replaced, will be disposed of.

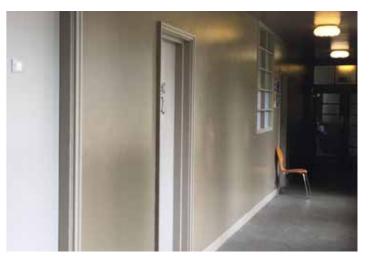
### Item no. 14

Internal non load-bearing partitions including skirtings (locations as noted on the consented demolition drawings)

Walls including finishes and/or tiling are to be removed minimising damage to any adjacent support structure or finishes which are being retained. In the new hotel corridors, care will be taken to protect the cork flooring during the strip-out works.

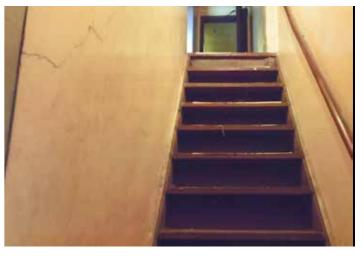
### Item no. 44

Former maintenance stairs leading to projection room

- The work will encompass carefully break up concrete stair flights, minimising damage/ trauma to the existing fabric within spaces subject to subsequent refurbishment, disposing of debris as work proceeds.
- In the case of steel framed stair flights, the work will be to carefully liberate primary support steelwork from the structural deck in a manner minimising trauma to the primary floor slab

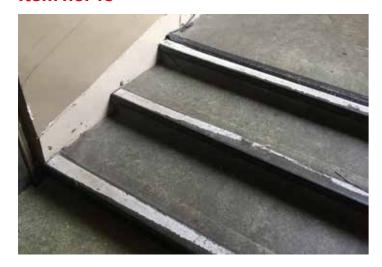
Item no. 15

**Item description:**Steps on the ground floor corridor G.4

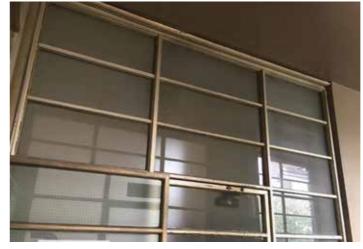
Item no. 11

Item description:
Glass partition on the ground floor and Lower Ground Floor of the East Wing which are within the demise of the hotel.

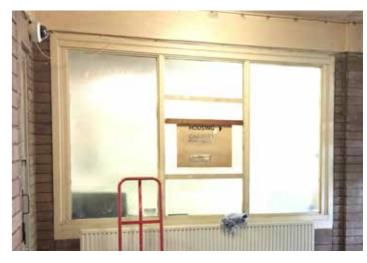
Item no. 48

**Item description:**Borrowed lights in LG.3

- These items will be removed alongside the partitions and doors which they are part of. It is likely that the transom lights over non-original doors are not original. Some of the original borrowed lights have later additions of wired glass
- The items will be carefully removed from any primary fabric, minimising damage, and the remedial works will include reinstatement/ making good any breakaway of any retained masonry/ plaster resulting.
- The removal work will minimise damage to the existing fabric by carefully removing any connections to retained floor, wall and ceiling/soffit plates, making good any enlarged holes or damage which is not subsequently destined to be concealed by a superimposed finish.

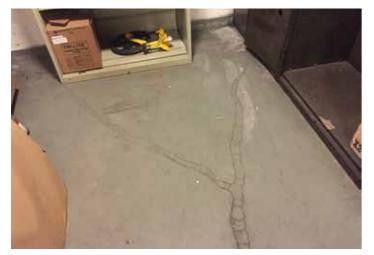
Item no. 28

**Item description:**Granolithic flooring on the Lower Ground Floor within the hotel demise.

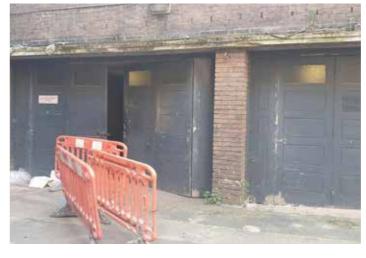
Item no. 69

Item description: External garage doors (LG.22, LG.22a, LG.22b)

- As with the louvred doors, care will be taken to minimise damage to the adjacent brick piers. Making good will take place where any repairs are required.
- The doors will be photographed and measured to replicate the pattern on the new doors.

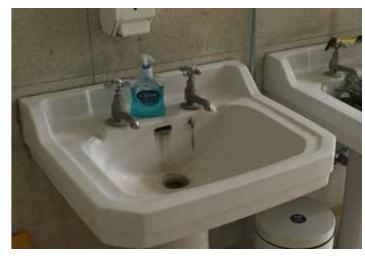
Item no. 04

**Item description:**Original taps in lavatories (basins retained). Many of the original taps have been replaced by modern taps.

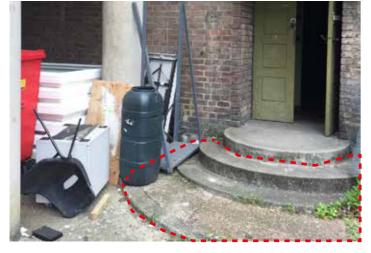
Item no. 64

**Item description:**2no concrete steps adjacent to stair ST-07

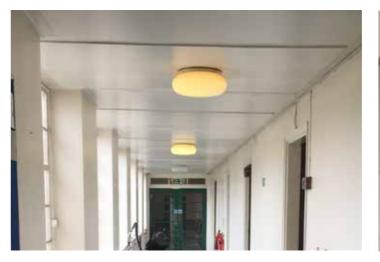
Item no. 22

Item description:
Laylights above non-original plasterboard panels located on the second floor corridor S.12

- The non-original plasterboard ceiling will be removed with care as the condition of the laylights above is unclear.
   There appears to be heavy damage to the finishes as there is evidence of water ingress into the corridor during rainfall.
- The laylights will be photographed and recorded. They will then be removed in sections to ease access through the building.
